ELMCREST DAM

NDI ID NO. PA-00347
DER ID NO. 35-142

PHASE I INSPECTION REPORT,
NATIONAL DAM INSPECTION PROGRAM

JULY 1981

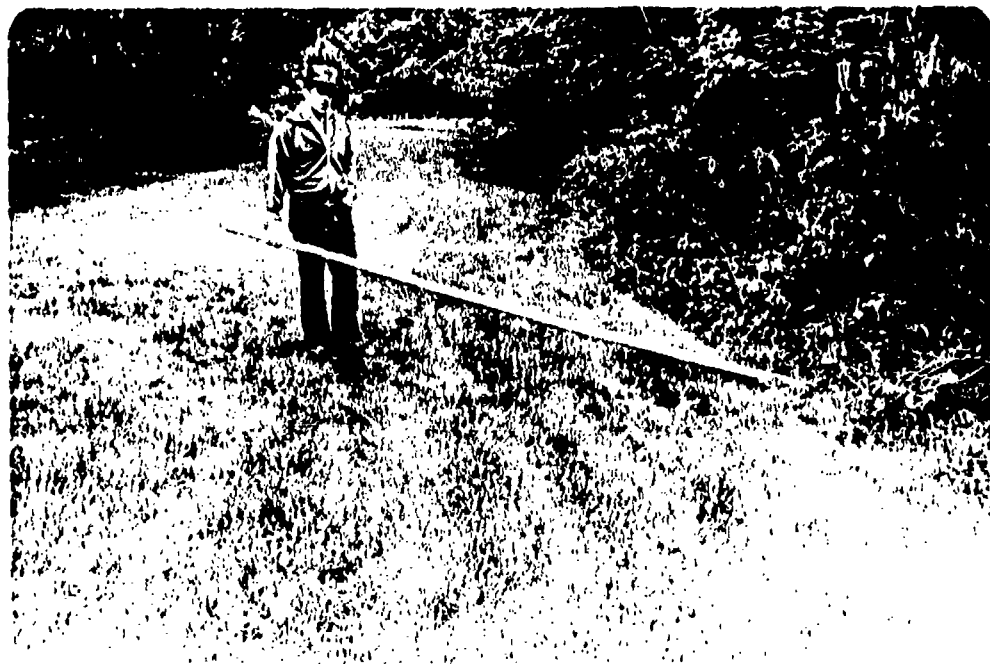
b. Embankment. The top of the embankment is covered with a stand of grass and is well maintained (Photograph A). There is a depression, about 15 feet in diameter, above the outlet works pipe (Photograph B). The depression extends from the axis of the dam to the downstream edge of the top of the dam. It is about 1.5 feet deep. The cause of the depression is unknown. It appears to be a localized settlement. Most of the upstream and downstream slopes are covered with mature trees and brush (Photograph B). In addition, some of the downstream slope is covered with a thick pile of grass clippings and other debris. Vegetation and debris obscured sections of the slopes. No deficiencies were observed on the unobscured sections of the upstream and downstream slopes.

The depression on top of the embankment would be of no concern if further settlement does not occur. Monitoring the depression is warranted. The bait ponds at the toe of the embankment could obscure seepage, although none was observed on the day of the inspection. The swamp near the left end appears to be a natural condition exacerbated by spillway flow.

B. Depression on Top of Embankment

(4) Visually monitor the depression on the top of the embankment. If changes are noted, implement remedial action.

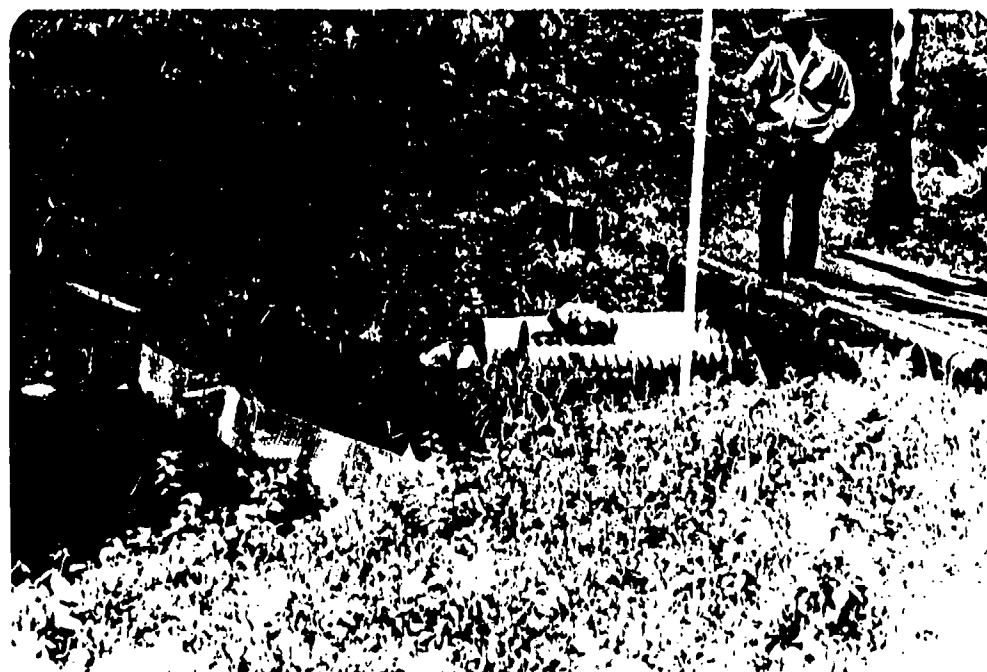
(3) Appurtenant Structures. For low-flow conditions, the approach losses in the spillway approach channel are judged to be appreciable; this explains the 0.5 foot difference in head between the spillway crest elevation and the pool elevation on the day of the inspection, when the quantity of flow was relatively small. As the pool elevation increases, the approach losses should become insignificant. The fish screen in the approach channel is judged to have no significant effect because it would collapse during any significant flow. However, the spillway itself is judged to have a very large potential to collect debris during a flood. It is conceivable that sufficient debris could collect to completely block the spillway. There is an erosion potential at the right end of the spillway, which is the left end of the embankment.

D. Spillway and Approach Channel

(1) Design and construct a spillway capable of passing the SDF. The spillway should be designed so as to eliminate both the potential for collection of debris and the potential for erosion at the embankment.

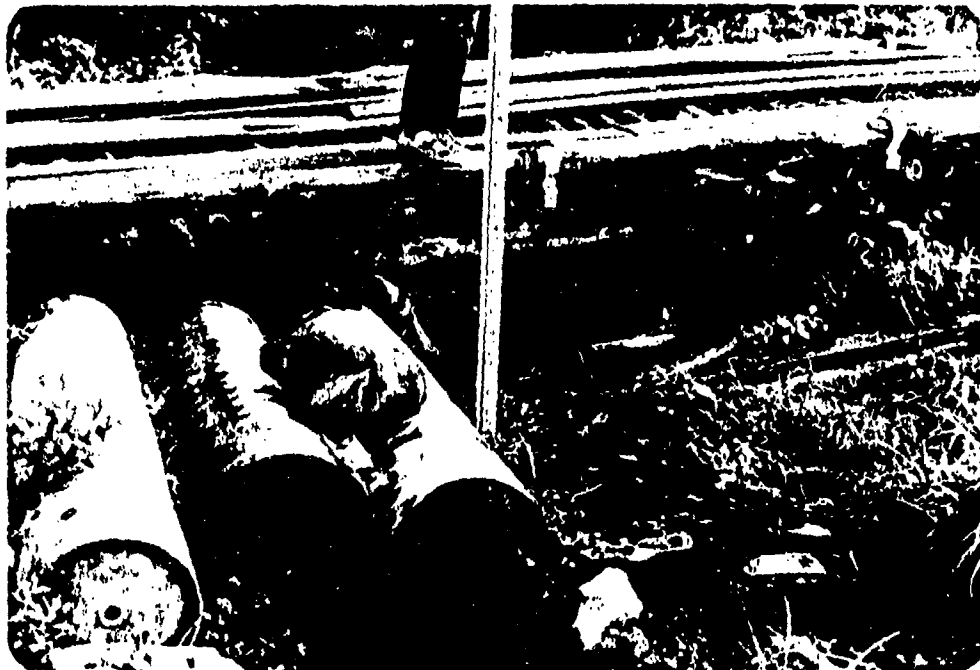
A minor amount of debris is accumulated at the spillway (Photograph E). The CMPs in the spillway are corroded through. The area of natural ground to the left of the spillway is heavily overgrown with thick brush and small trees. The right side of the spillway is the embankment. It is covered with vegetation. The spillway exit channel is not well-defined as it extends through the swamp to the bait pond.

E. Spillway

(2) Remove debris and clear trees and brush on or adjacent to the embankment.
